Volume 15 Number 6

March 29, 2005

**Mangrove Degradation  
Resulting from Transitions  
in Freshwater Management**

# Transitions in Ancient Inland Freshwater Resource Management in Sri Lanka Affect Biota and Human Populations in and around Coastal Lagoons

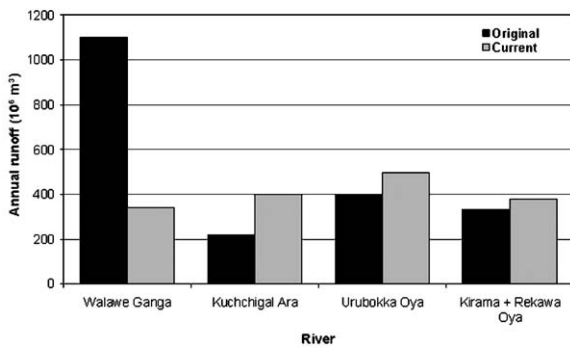
Figure 4. Runoff Changes Owing to the Waterwork Infrastructure Comparison between the average annual runoff before and after the construction of the Udawalawe Scheme. For calculation details and statistics, please refer to the [Hydrological Calculations](#) section of the [Experimental Procedures](#).

A comparison was made of the average annual runoff for each of the catchments leading to the lagoons before and after the construction of the Udawalawe Scheme. This comparison was based on total water balance (see Equations 1 and 2), the calculation of which is one of the most basic in hydrology and highly relevant in this type of study [48, 49]. For the Walawe River, original and current flow data were obtained from the International Water Management Institute (IWMI). For the rivers feeding the three study la-

goons, flow data representing an original situation without water development works were obtained from a long-term hydrometeorological study [3]. For current flow, calculations are based on a calculated return flow of irrigation water from the Udawalawe Reservoir to the study catchments; the calculations take into account irrigation demands and surfaces [12] and reservoir and crop evaporation and evapotranspiration rates [12, 50] (Figure 4). Infiltration into groundwater is a negligible factor because no major groundwater aquifers have been found anywhere in the Walawe basin [13]. There was also no indication of a significantly larger precipitation after the hydrological works. On the contrary, national and local long-term hydrometeorological studies in the south of Sri Lanka report either no significant trends or a decrease in rainfall and runoff over the past four decades [27, 51, 52]. In the original situation, the total discharge for the Walawe catchment and the three lagoons equalled  $2050 \times 10^6 \text{ m}^3$ . This is reduced in the current situation to  $1616 \times 10^6 \text{ m}^3$  because of an increased evapotranspiration of  $460 \times 10^6 \text{ m}^3$  from the irrigation schemes and the reservoirs fed by the Walawe River. The total water balance of the entire system is not significantly different before and after the hydrological works ( $\chi^2 = 0.150$ ; degrees of freedom = 1;  $p > 0.1$  not significant). The decrease in discharge in the Walawe River is compensated by an increased evapotranspiration but also by an increased discharge to the three lagoons as a result of the return flow from the irrigation schemes (Equation 1):

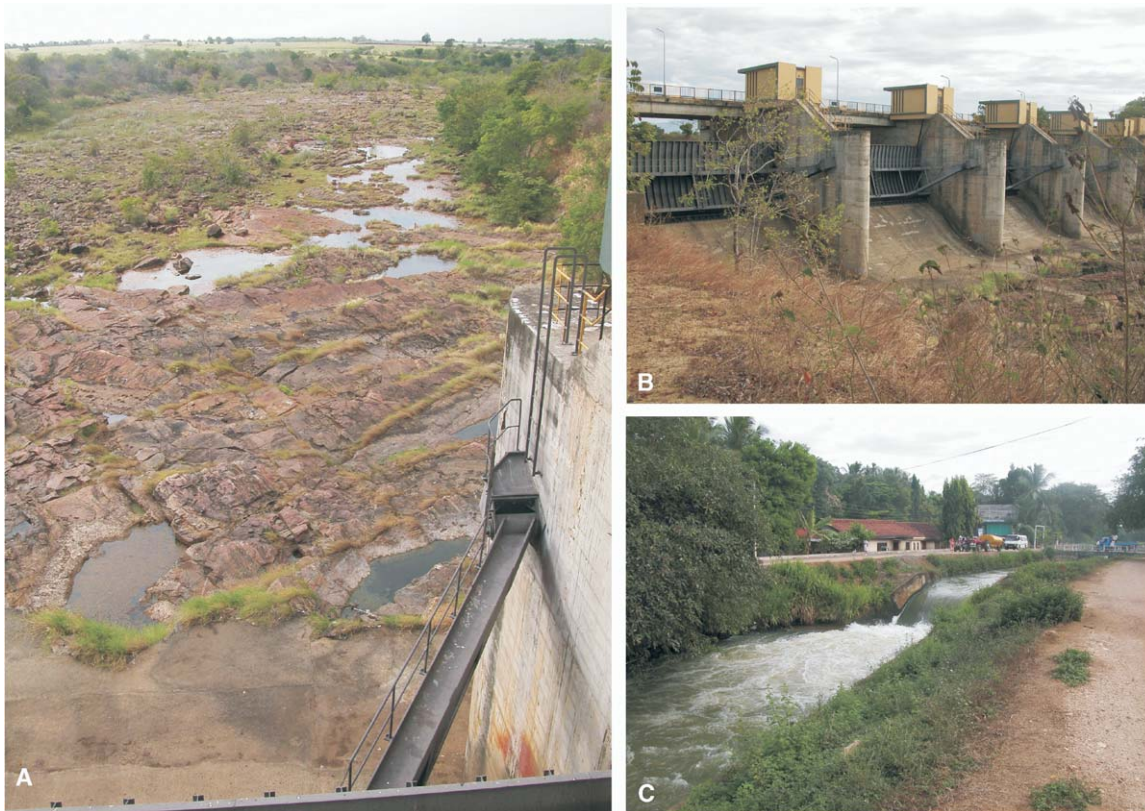
Figure S1. Photographic Evidence of the Reduced Discharge of the Walawe River and the Increased Discharge to the Catchment of the Other Rivers under Study (August 2004)

(A and B) Original river bed of the Walawe River; photograph taken from the top of the closed spill gates (B) of the Udawalawe Reservoir (southernmost point). The dry river bed in the photographs is indicative of a strongly reduced discharge.
